Technical paper

Gear Tooth Flank Flaking Associated with White Etching Area

Cases of rapid tooth flank damage have recently been sporadically appearing in assembly tests of gears (cylindrical gears and bevel gears) used in construction machinery powertrains. The damage to the tooth flanks has started to be recognized as a new failure mode (called gear flaking with white etching area) in which internal cracks form that are associated with white structure (white etching area). Since gear flaking with white etching area has not been reported in gears operating normally in the market, it is considered to be a phenomenon unique to assembly testing. Its cause has not been explicated. However, it is frequently reported in cases of bearing rolling contact fatigue, which are considered a similar phenomenon. So using the flaking with white etching area found in bearings as a reference, we have aimed to find a solution to the flaking with white etching area found in gears by examining white etching area, studying the generation mechanism and studying the effects of causes in gears.

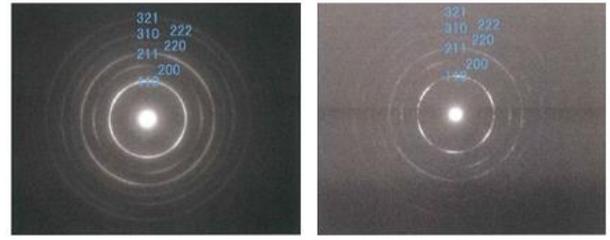
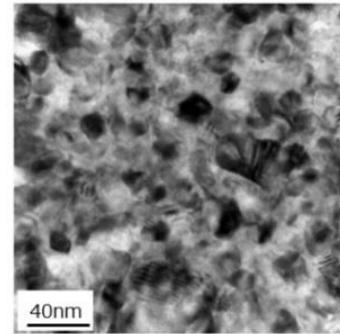
Fig. 2 TEM observations of gear white etching area

We then examined white etching areas in gears using a Transmission Electron Microscope (TEM). We examined their crystal structure and found that it exhibits the halo pattern shown in **Fig. 2** (a), and may be an ultramicroscopic crystal with a bcc crystal structure (ferrite structure) periodicity. The white etching areas we found in bearings are also shown for comparison. We found they exhibit the same crystal structure. **Fig. 2** (c) is a photograph of the structure, which are equiaxed crystals of between 10 and 20 nm. We measured their hardness with a Vickers microhardness tester. We found the white etching area had a hardness of about 1,230 HV, while carburized martensite had a value of about 830 HV. This large difference in hardness could have been responsible for generating fatigue cracks at boundaries of white etching area.

(a) Electron diffraction image of gear white etching area (b) Electron diffraction image of bearing white etching area

(c) Photograph of white etching area

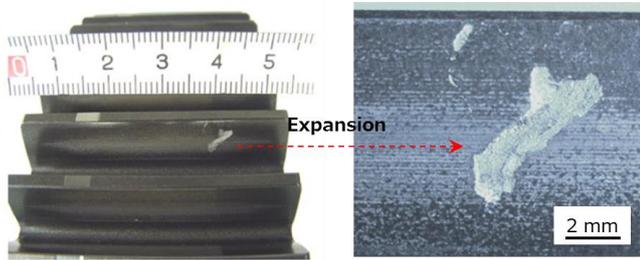
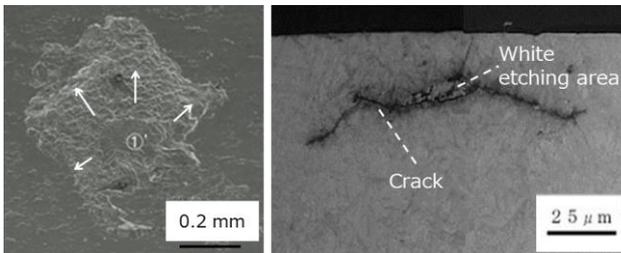
Fig. 1 Gear flaking with white etching area example

Fig. 1 shows an example of tooth flank flaking associated with white etching area generated during assembly testing. The common type of gear tooth flank damage is pitting failure originating from the surface, but as shown in **Fig. 1** (a), flaking associated with white etching area is a failure mode that is difficult to clearly differentiate from pitting failure by sight. We examined locations of minute flake generation in the same gear to find out where flaking originates from. As shown in **Fig. 1** (b), we found that cracks grew and developed into flaking from disk-shaped surfaces near the centers of fractures. We also examined tooth cross-sections and found multiple white etching areas and cracks generated inside as shown in **Fig. 1** (c). This finding indicates that the flaking originated from white

etching area generated inside (tooth flank flaking associated with white etching area). Similarly, we examined white etching areas and cracks in multiple gears, and found the following characteristics:

(a) Tooth flank damage (flaking with white etching area)

(b) Fractures with minute flaking (c) Internal white etching area and cracks

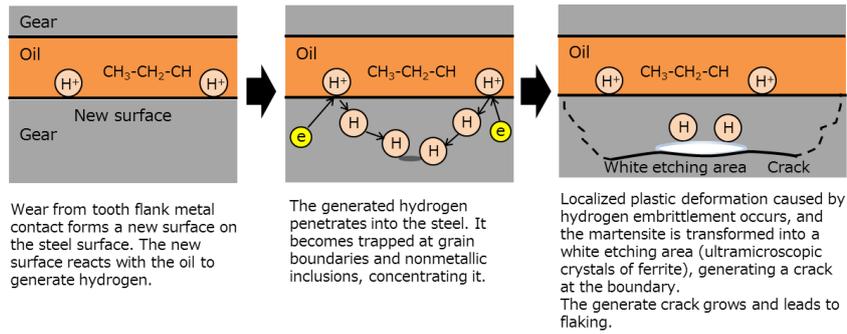
Fig. 3 Mechanism of gear flaking with white etching area

Since we found that white etching areas in gears are the same as the structure found in bearings and are the same rolling contact fatigue phenomenon, the flaking with white etching area found in gears may essentially be the same as the hydrogen embrittlement-based rolling contact fatigue [3] [4] found in bearings. However, white etching areas have been found to have different occurrence depths and modes in gears from those in bearings. This finding may be due to the effects of the different materials, sliding states and stress fields in gears and bearings. Gears are generally used at higher pressures than bearings, and have higher slip factors. Gears also generate friction as they engage. These factors may affect white etching area generation by affecting sliding surface states and the diffusible hydrogen that penetrates the steel. **Fig. 3** illustrates the mechanism thought to be responsible for flaking with white etching area in gears.

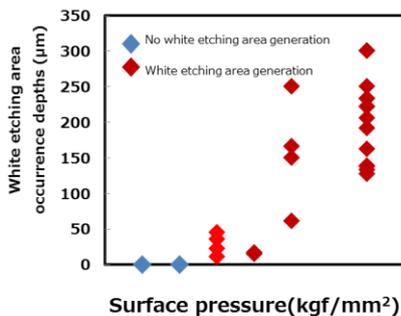
Fig. 4 Effect of surface pressure on white etching area

Fig. 4 shows the results of surface pressure effect evaluated by a gear tester. The results indicate that low surface pressure does not result in white etching area, but white etching areas are generated near the surface as surface pressure increases. Further increasing the surface pressure starts to generate white etching area at deep locations. We also found these surface pressure effects in roller pitting tests done by maintaining a constant slip ratio and varying the surface pressure. Increasing the surface pressure creates a more severe sliding condition, promotes the formation of new surfaces, and promotes the entry of hydrogen into the steel. The penetrating hydrogen may also have been subjected to stress field effects, becoming more easily trapped by grain boundaries and nonmetallic inclusions.

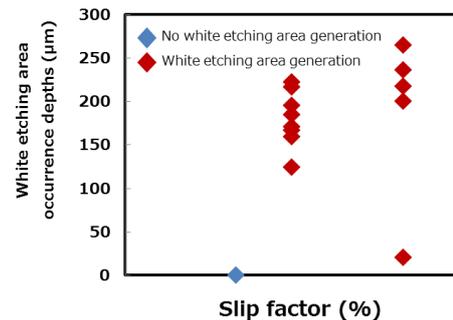
Fig. 5 Effect of slip factor on white etching area

While bearings roll without slip, the meshing of gears generates a large amount of sliding. To evaluate the effects of this sliding, we conducted roller pitting tests that varied the rotary speed of two cylindrical test specimens to test with different slip factors. The tests used a constant surface pressure for generating white etching area, and varied the slip factor. As shown in Fig. 5, we found that increasing the slip factor tended to promote the generation of white etching area. This finding may indicate that increasing the slip factor promoted the formation of new surfaces from sliding, and promoted hydrogen generation.

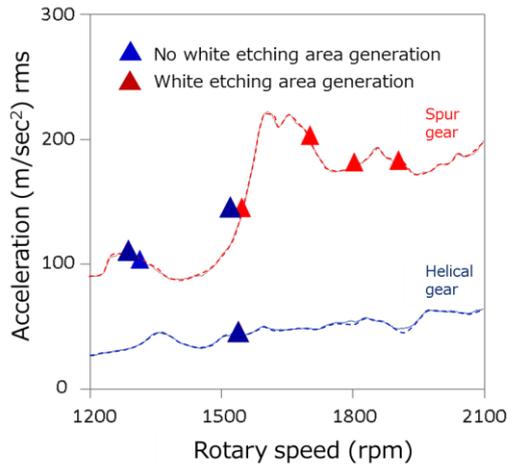
Fig. 6 Effect of vibrations on white etching area

Gear vibrations may affect the generation of white etching area since they change sliding and stress states. To enable changes in vibration magnitude, we used spur gears and helical gears in our gear tests. Acceleration sensors were attached to gear side surfaces to measure gear vibrations directly. Testing was done by measuring vibrations while varying the rotary speed initially, and then subsequently keeping the rotary speed constant. Fig. 6 shows the test results. We found that helical gears with low vibrations did not generate white etching area, while spur gears with large vibrations were prone to generating white etching area. This finding may indicate that the combined effects of sliding and stress fields generated hydrogen and promoted its accumulation.

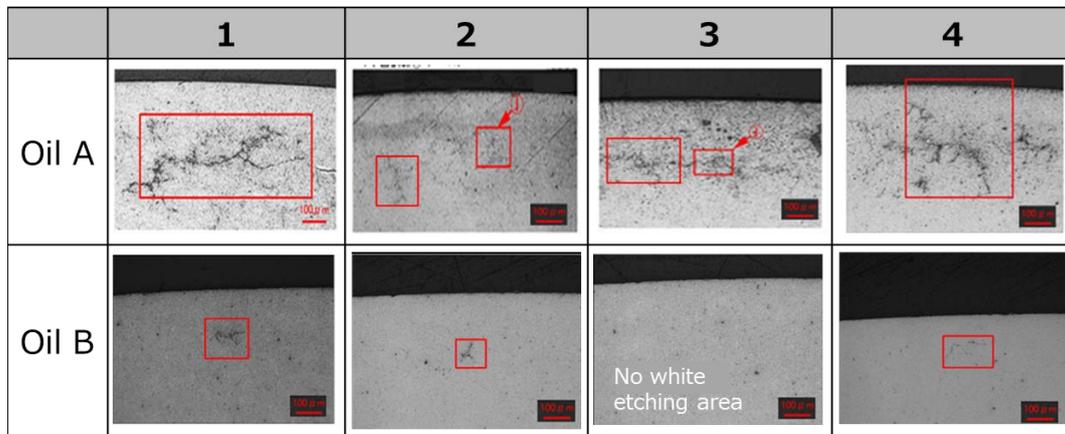
Figure 7 Differences in white etching area generation caused by different oil types

in the tests, and white etching areas were observed after testing. Fig. 7 shows the white etching area observed. We found that Oil B inhibited the generation of white etching areas more than Oil A under the same test conditions. Since the Oil A and Oil B had equivalent kinematic viscosity, the change in lubrication states due to oil additives may have been the cause of white etching area.

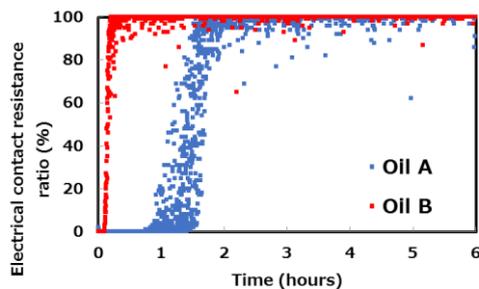
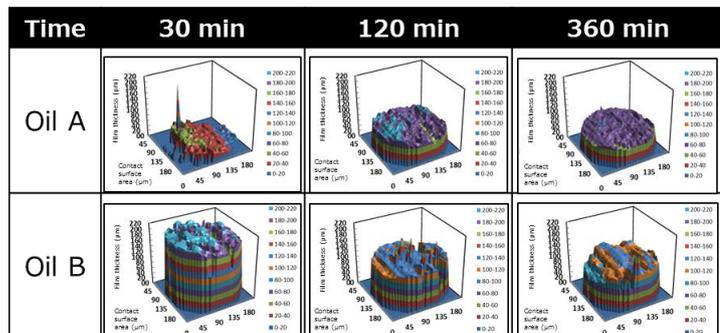
Figure 8 Sliding state changes caused by different oil types

To investigate the difference in lubrication states between Oil A and Oil B, we focused on the behavior of tribofilms generated on surfaces by reactions between oil additives and steel and measured film deposition rate in MTM (Mini Traction Machine). Fig. 8 (a) shows the result of the Electrical Contact Resistance (ECR*) in each oil, and we can estimate the film deposition rate with ECR. Since metal contact is inhibited as a tribofilm is generated on a sliding surface, ECR changes. Fig. 8 (b) shows the thickness of the generated tribofilm. As shown, Oil B resulted in faster tribofilm generation than Oil A. This faster tribofilm generation may have restrained hydrogen penetration from new surfaces, which causes white etching area.

(a) Change in Electrical Contact Resistance (ECR*)

(b) Tribofilm thicknesses
